MOENJODARO: A WORLD HERITAGE SITE AT RISK

Enrico Fodde and Muhammad Safdar Khan

The aim of this paper is to describe the main threats affecting Moenjodaro, an archaeological site that prospered from 2350 to 1800 BC in the fertile Indus flood plain of Sindh (Pakistan). The major hazard is today represented by soluble salts attack (mainly sodium sulphate), rising damp, heavy precipitation in the monsoon season, poor drainage, thermal stress causing walls to lean and decay structurally, visitor behaviour, site mismanagement, and the lack of vegetation. As a result of poor conservation and bad management, in the year 2000 the site was inscribed in the ICOMOS register of heritage at risk. The paper analyses past and present conservation methods, and provides recommendations for future repair and maintenance.

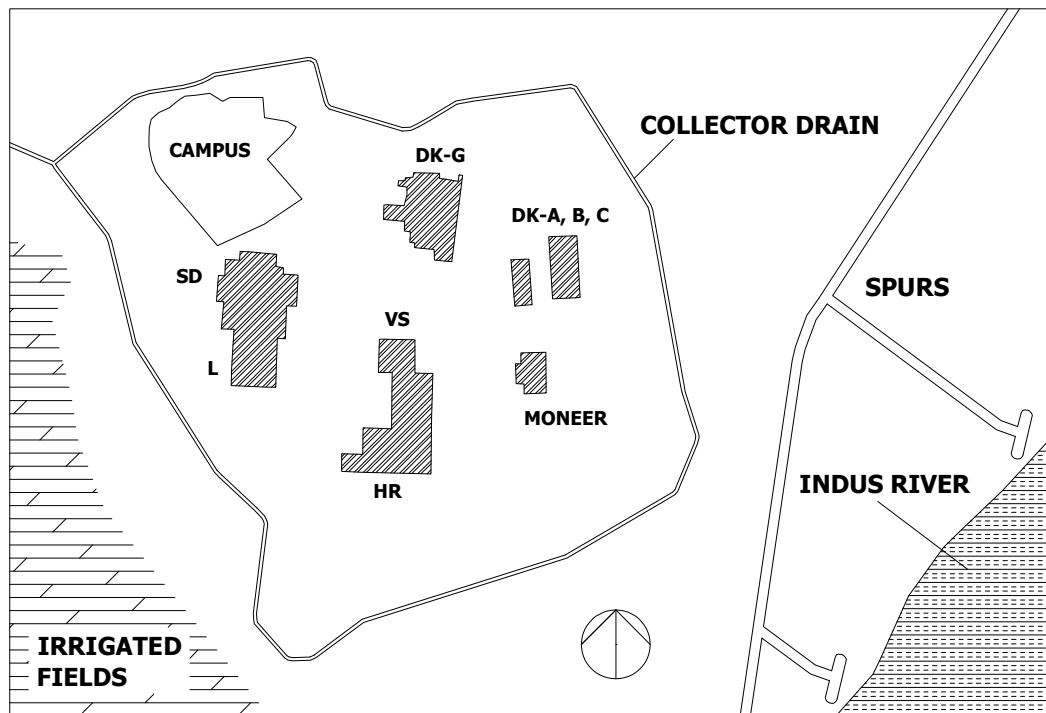
Figure 3: Schematic plan of Moenjodaro with extent of excavated areas

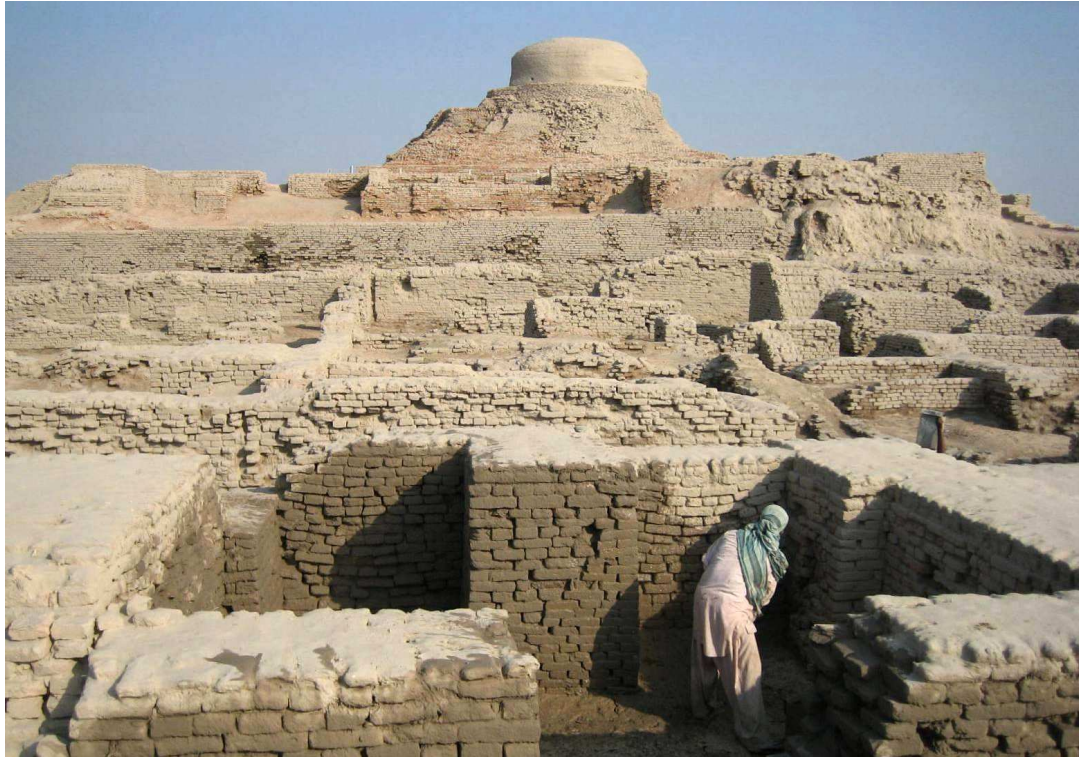
- The agricultural land around Moenjodaro has high salts content and this is increased by the irrigation system: fields are inundated with water for weeks and this makes the water table rise (see Figure 4 for proximity of fields to the site). As a result water tends to migrate towards the structures and salts crystallize on the surface. There is an urgent need to stop the cultivation of paddy crops to overcome the problem.

Figure 4: View of SD area with mud brick stupa

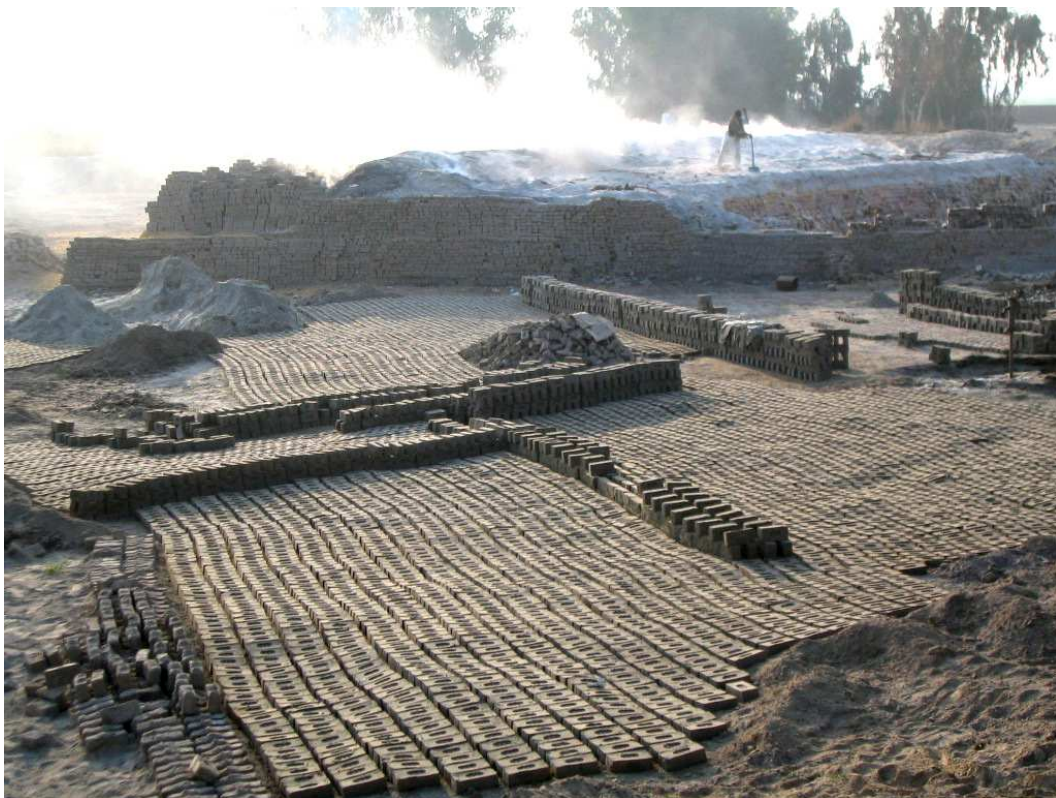
Moenjodaro's historic fired bricks measure 6.3 x 13.4 x 27.9cm. There is no proof on how fired bricks were manufactured in the third millennium BC but it is likely that the methods employed did not differ much from those in use today (Figure 7). The area around Moenjodaro is scattered with kilns for firing bricks that use a mix of mix of loam, rice-husk ash, sand and water as raw materials. Similarly to practices in Britain in the Middle Ages, ashes are necessary in the mix '...so that the green bricks provide some of their own fuel'.⁸ The mix is tramped by feet and left to rest before moulding. After drying, the green bricks are stacked to form clamp-kilns that are roughly rectangular in form. Rice husk is employed for kindling and the firing continues for up to four days.

Figure 7: Clamp kiln in the outskirts of Moenjodaro showing brick drying and firing.
